EMIR receiver: report of hardware installation and tests

V1.0 - April 2, 2009

During the second week of March 2009 and after twelve years of successful operation, the old HDV-10 cryostats were stopped and removed from the receiver cabin of the 30m telescope. Then, one week later, the new single cryostat EMIR receiver was installed and its hardware and control software was successfully tested. Measurements in the cabin closely match previous data taken in the laboratory in Grenoble while first tests on the sky seems to indicate an excellent co-alignment of the beams and very good coupling to the telescope. For the first time in the life of the 30m telescope an helicopter flight was used to transport the receiver assembly to the observatory.

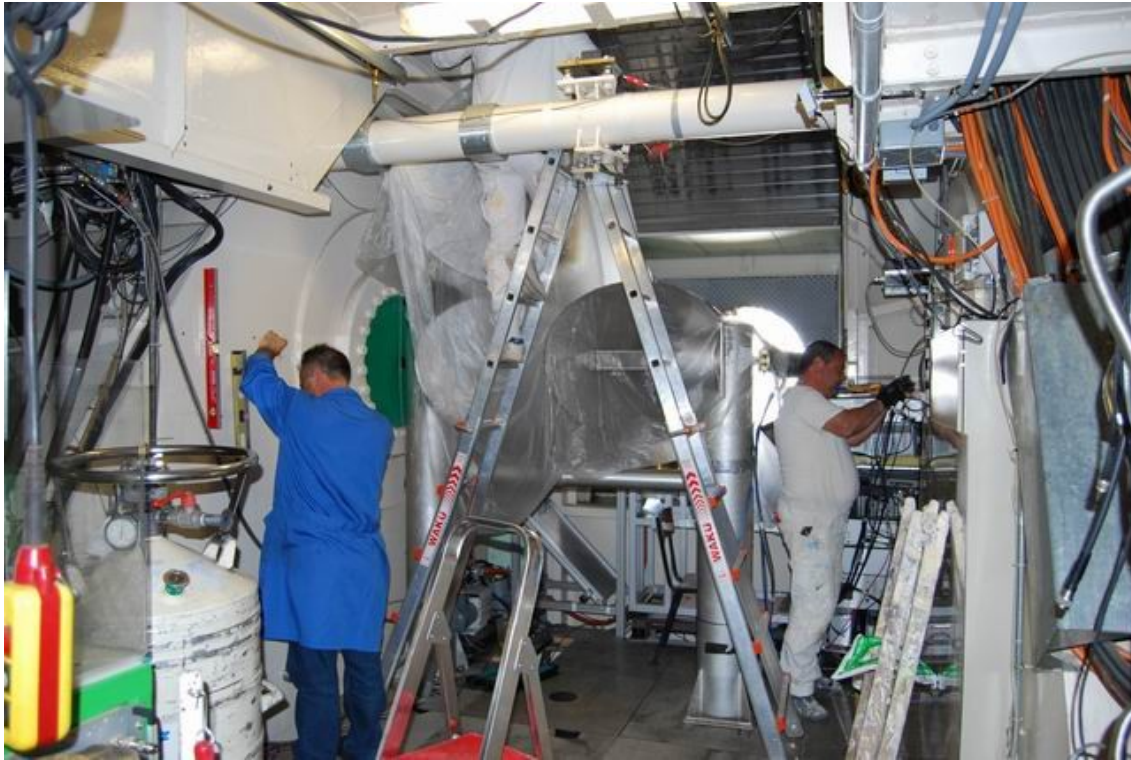
Figure 2. Painting over the Nasmyth mirrors.

Since 1997 the receiver cabin wasn't that empty so it was decided to take the chance to paint it. The fourth, and part of the fifth day, were entirely devoted to the painting of the cabin - an activity with a non negligible risk for the remaining equipment in the cabin, as can be guessed from picture 2.

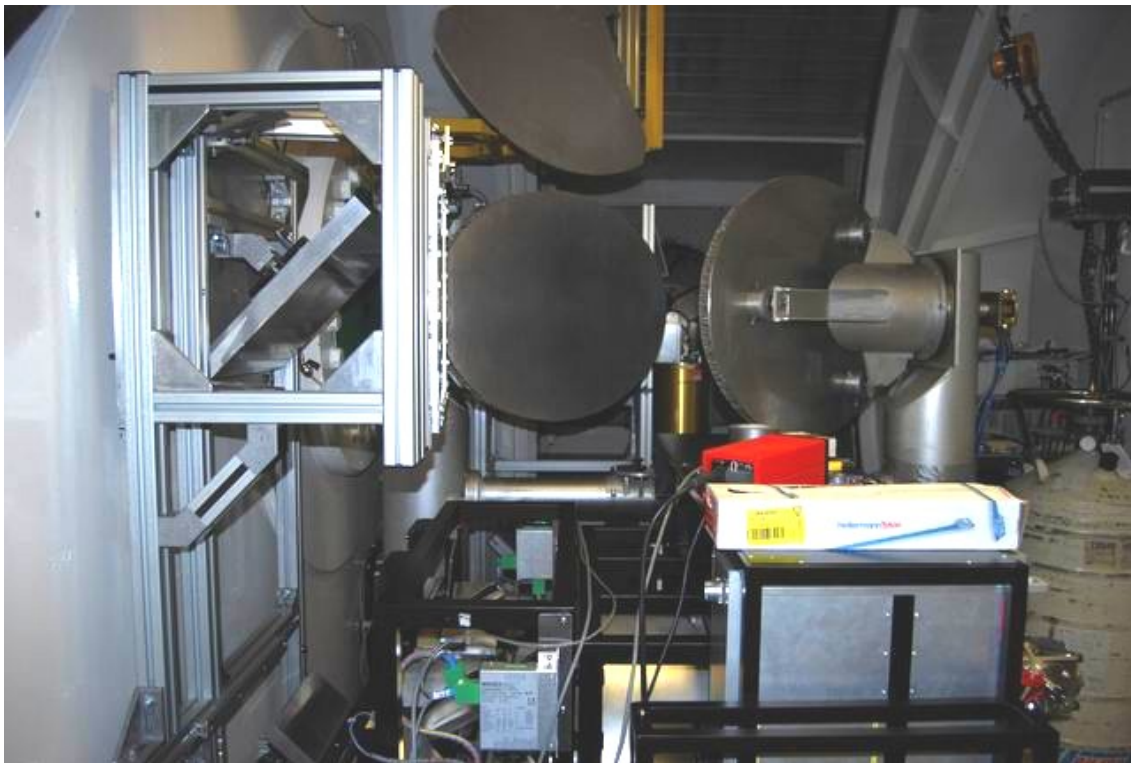
Figure 3. View of M4 from the Hera input.

Once the alignment with the laser on the elevation axis was finished another laser, installed on the EMIR frame, was switched on and the global optical alignment was checked from the receiver up to the subreflector. While making the alignment of the external optics a possible vignetting problem of the Hera beam was identified. The position of M5, when closed, could be cutting part of the Hera beam. The mirror was carefully adjusted to reduce the problem to a minimum. Some more checks for truncation will be needed, anyway. Fig. 3 shows

a picture taken from the Hera input. The last activity during the day was the insertion of the EMIR cryostat in its frame and the connection to the vacuum pump.

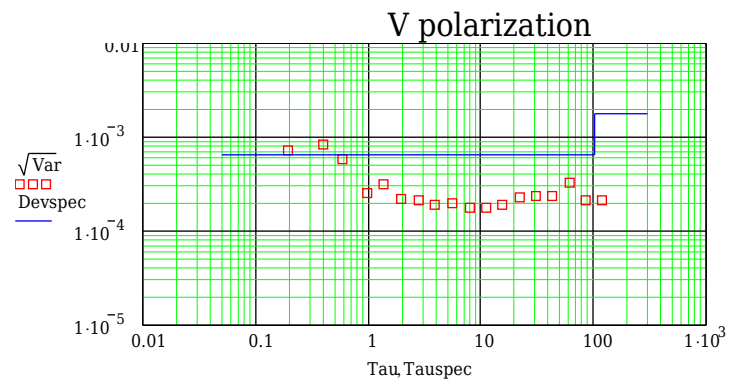
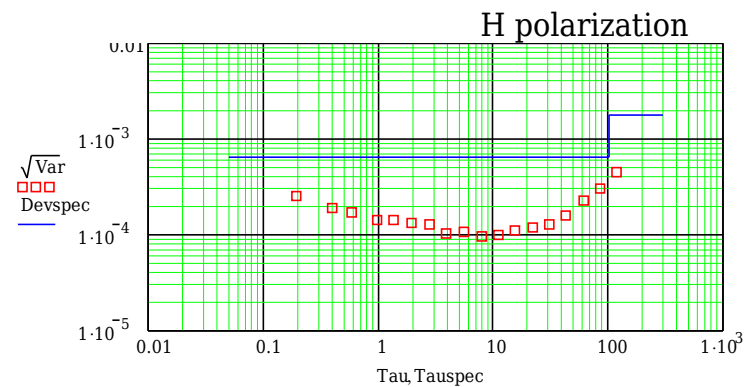
2.7.1 Band 1 (E0). 101 GHz LO USB.

Stability measurements were performed at the output of the receiver's warm IF amplifiers. Using an Agilent E4419B dual-channel power meter, with two E9300A

sensors. Two polarization channels were acquired in parallel. Total duration of data was 600s at a sampling of 200ms.

For each measurement, three graphs are displayed:

- ♦ Allan deviation ($\sqrt{\text{var}}$) versus timescale; the blue line shows the ALMA specification for total power stability.
- ♦ Time plot
- ♦ Spectrum; resolution 1/600s, first two channels masked to better display low level features. The plotted quantity is *amplitude* (not power), on a scale such that the mean value (1) of the normalized power corresponds to a 0-Hz spectral component of amplitude unity.

Plots are shown first for the V channel, then the H channel.
